# ST ALBERT HERITAGE SITE FUNCTIONAL PLAN PHASE 1

CONSERVATION OF 1906 BRACKMAN-KER ELEVATOR

CONSERVATION OF 1929 ALBERTA WHEAT POOL ELEVATOR

MUNICIPAL HERITAGE FORUM 2011

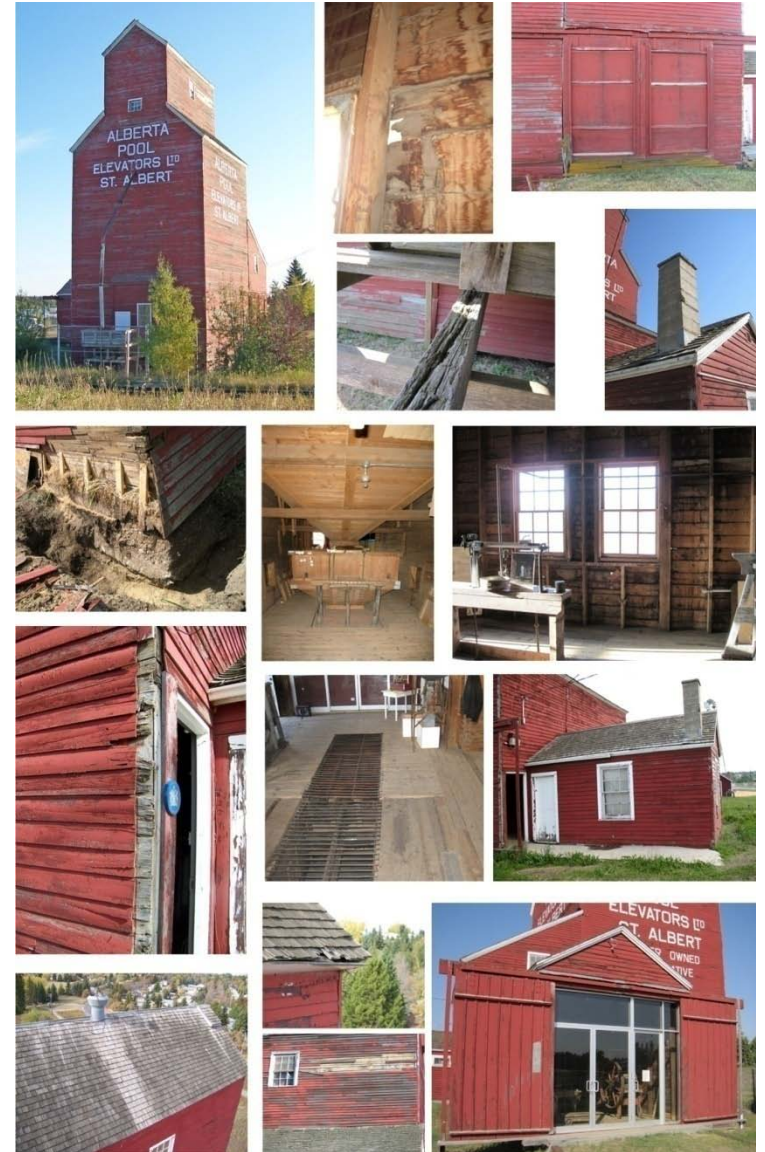
### ELEVATOR 1 – CONDITION ASSESSMENT

An observation of the 1929 Alberta Wheat Pool Elevator will invariably focus on its appearance and the deterioration evidenced in the siding. Nevertheless it is the hidden and unexpected conditions that present the greatest risk to the building.

Elevator 1 is generally in good condition given the buildings age but there are areas of concern that require interventions to ensure the longevity of the structure. Additional interventions are recommended to mitigate against potential damage to the building in the advent of a fire and are combined into a single construction project.

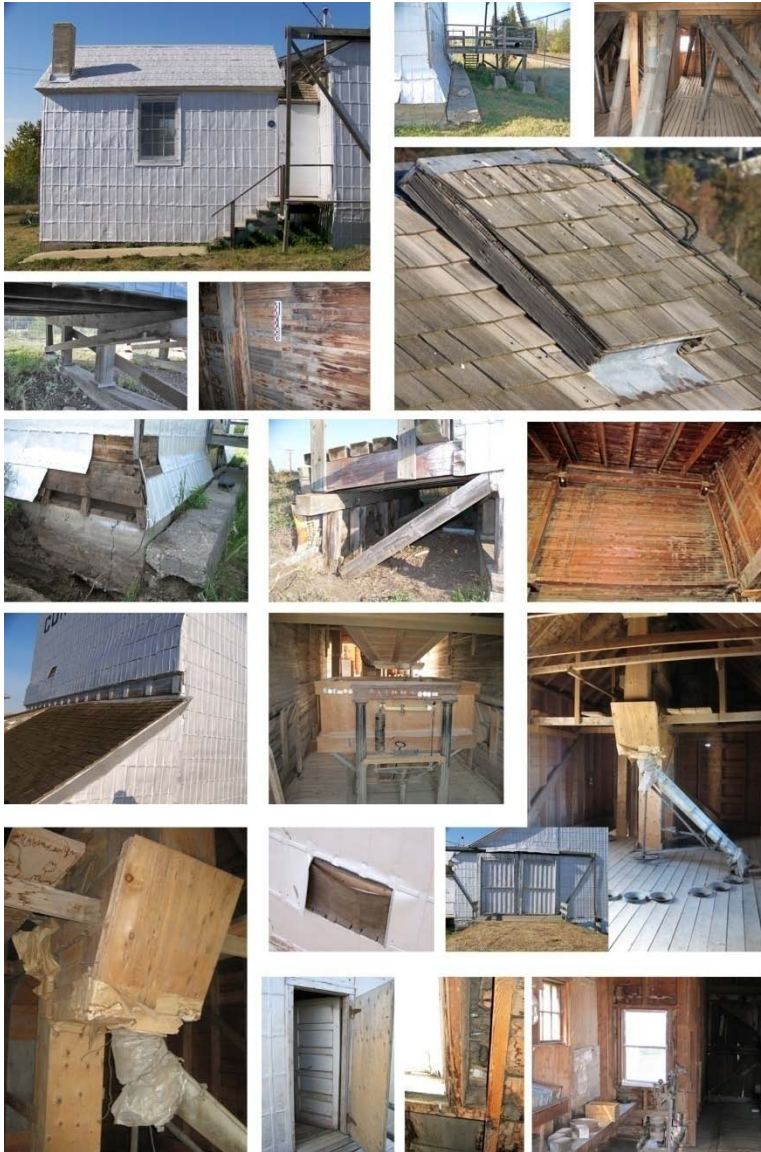
### ELEVATOR 2 – CONDITION ASSESSMENT

Elevator 2, the 1906 Alberta Grain Company Elevator is in very good condition given the buildings age. The metal cladding has helped to shield the building from the ingress of rain and the observed effects on the wooden structure are reduced. There are however a number of areas of concern that require interventions to ensure the longevity of the building related to the structure itself.

The building has a slight lean that needs to be addressed. It is unknown if this occurred when the building was raised in 1937 or if the situation has progressively deteriorated. The building is not in any immediate danger but during the course of the restoration the foundations under the grain storage bins will be modified to prevent further distress to the building. The eastern portion of the drive shed roof also needs attention to correct the deformation caused by the sinking of the support post in the north east corner.

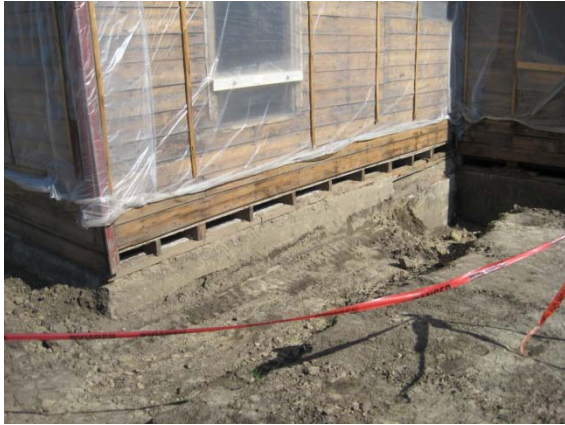
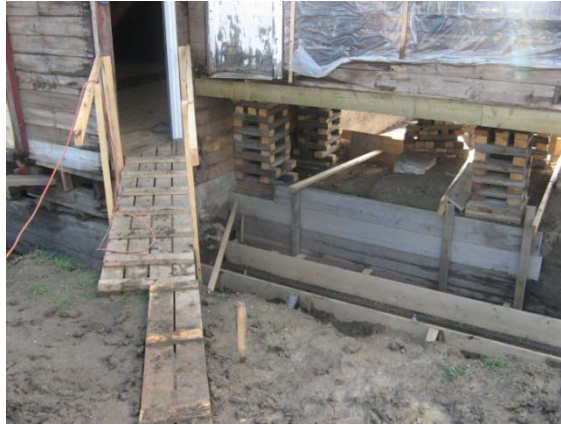
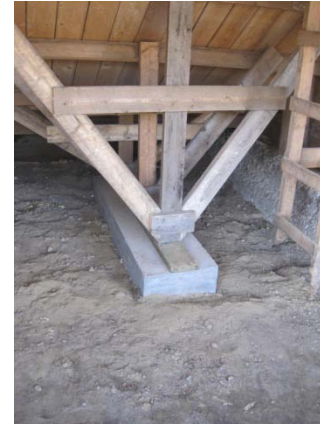
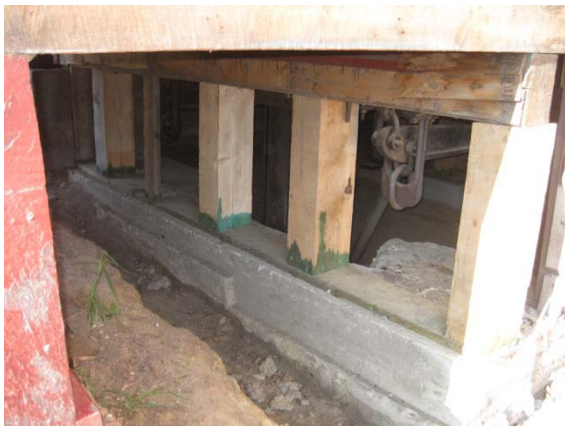
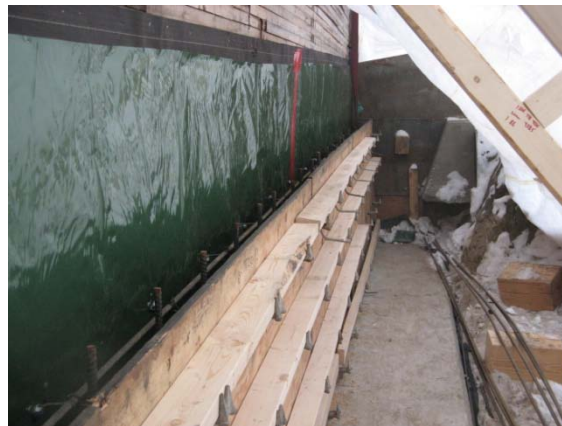
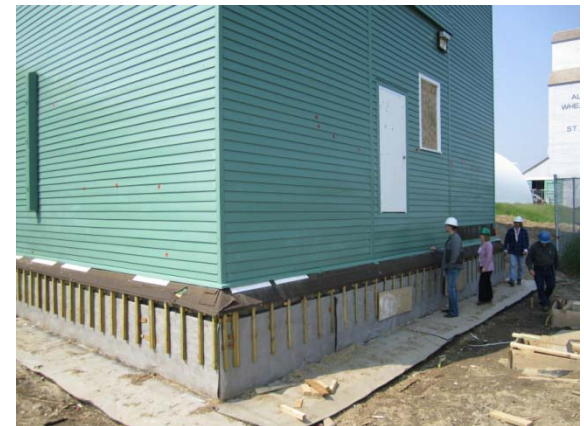
## ELEVATOR 1 – FOUNDATIONS

Create concrete upstand wall on north of foundation under grain storage bins and increase height of upstand between grain storage bins to mitigate water penetration

Repair / replacement of structural elements to drive shed. Review crack in west foundation wall.

Replace office foundations.

Disassemble supports to east drive shed, repair / replace as necessary and treat with preservative and re-construct.

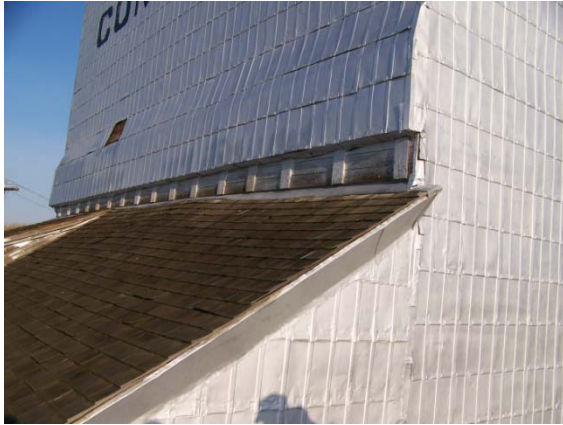
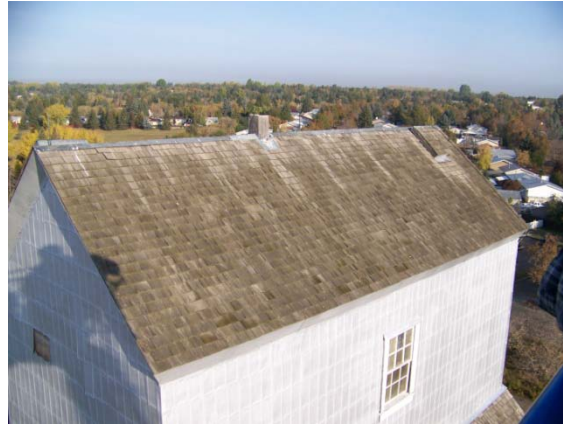
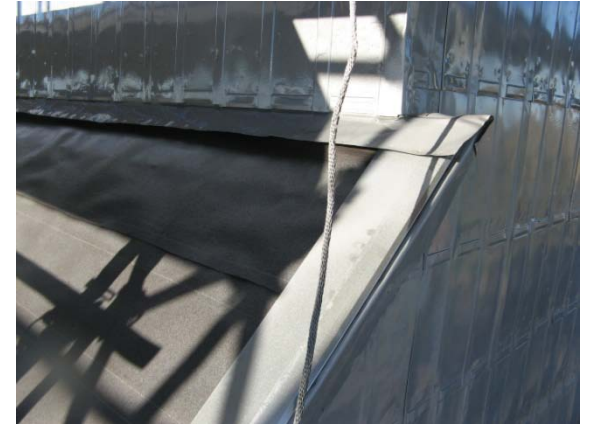
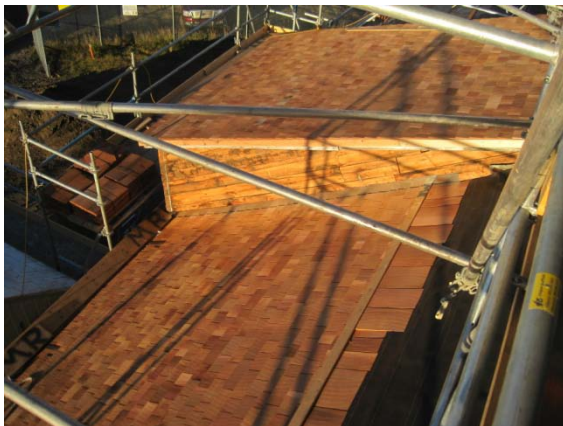
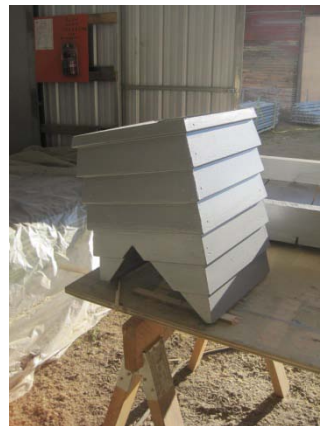
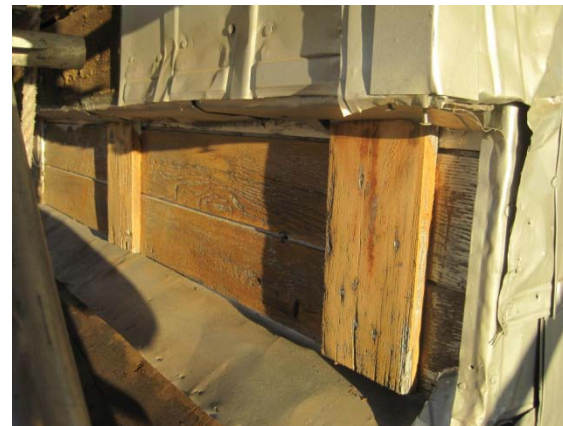
## ELEVATOR 2 – ROOF

Upper roof - Remove existing shingles, apply intumescent coating to roof sheathing, 2 layers of building paper and new shingles. Replace roof access hatches and install cover to vent. Replace flashings and fascia as necessary

Office roof - Inspect metal roofing, review fascia and flashings for re-use, install new eaves trough and downspouts. Repoint chimney and repair flashing

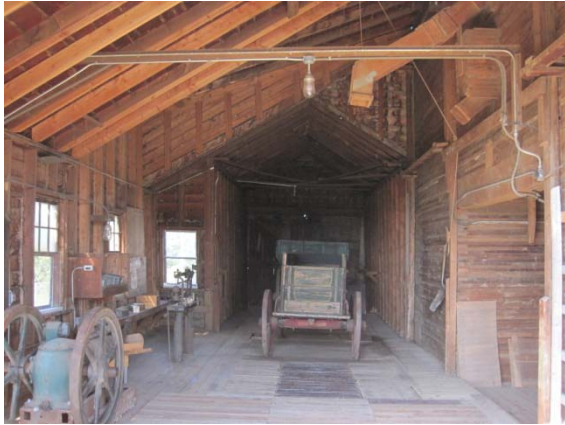
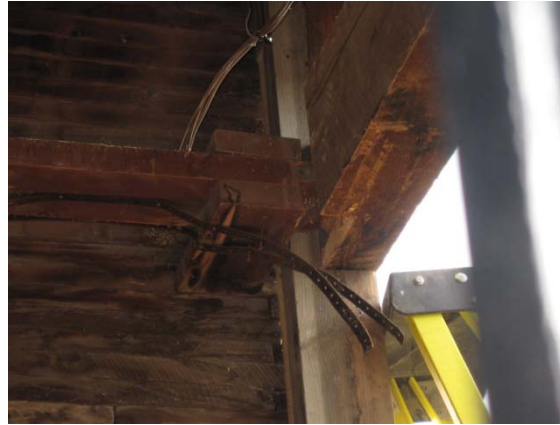
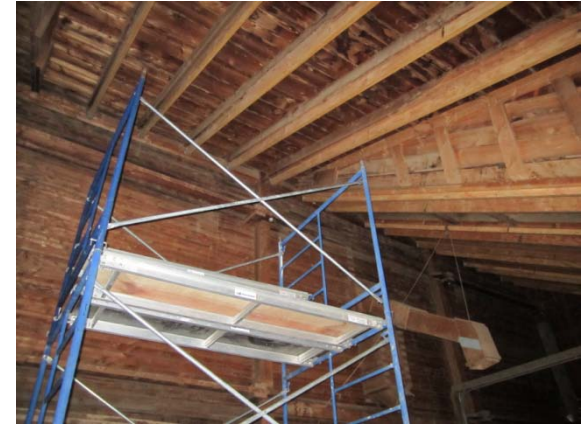
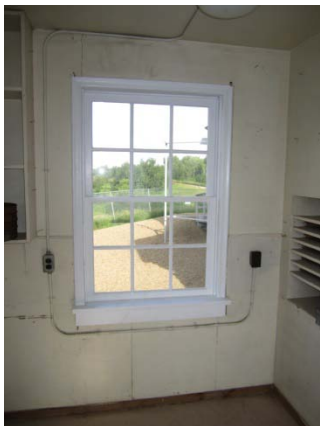
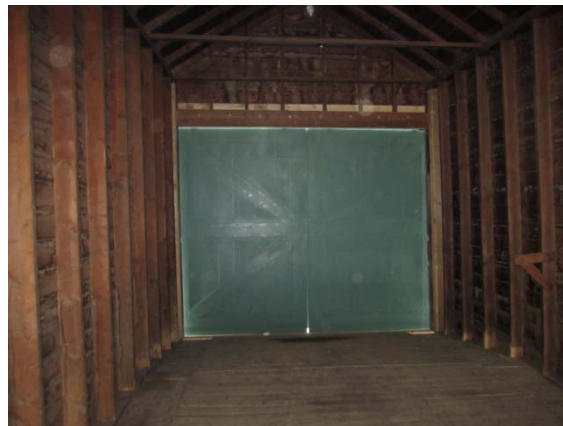
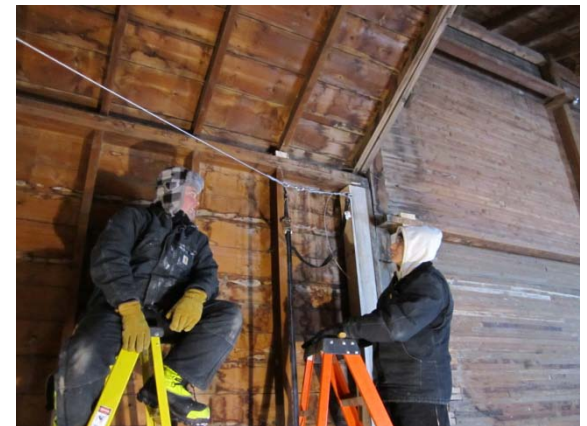
## ELEVATOR 2 – INTERIORS

Allowance for minor repair to office following restoration works to windows, paint touch up, floor cleaning and minor repair and intumescent coating.
